MTL TR 92-44

# LAU-7/A MISSILE LAUNCHER ATTACHMENT BOLT FAILURES

VICTOR K. CHAMPAGNE, MARC S. PEPI, and  
GARY WECHSLER

July 1992

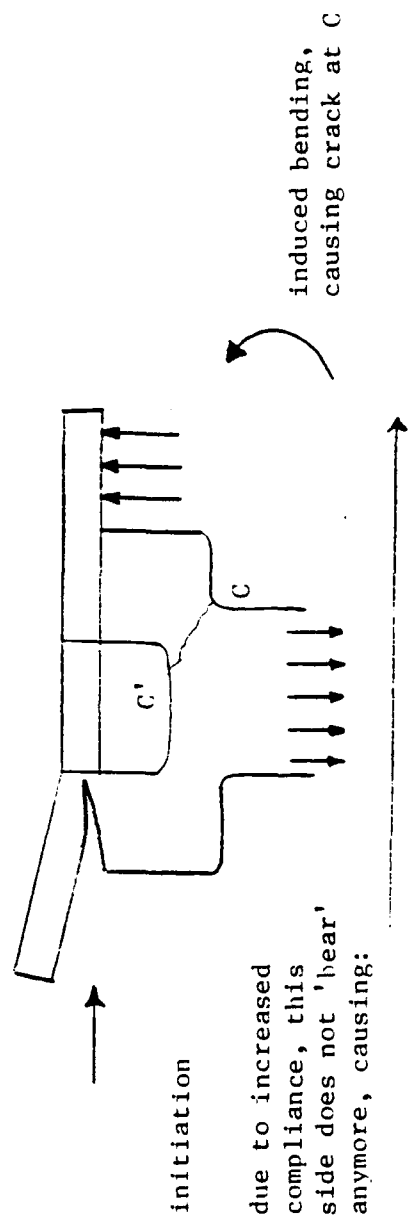
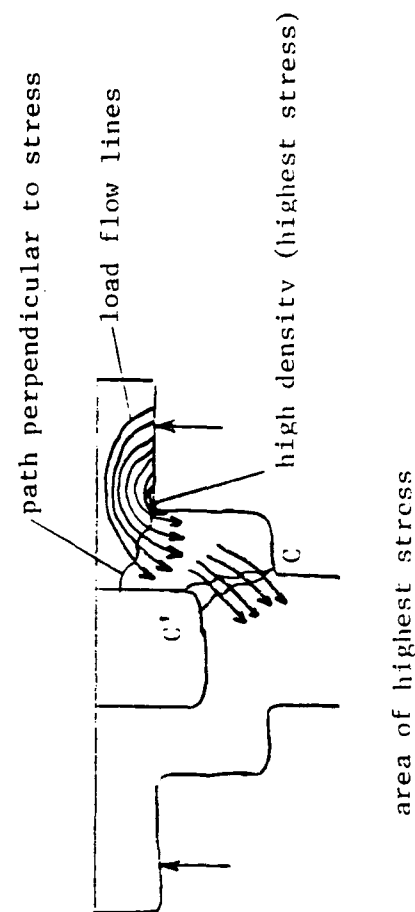
Figure 8. Load flow and stress concentrations.

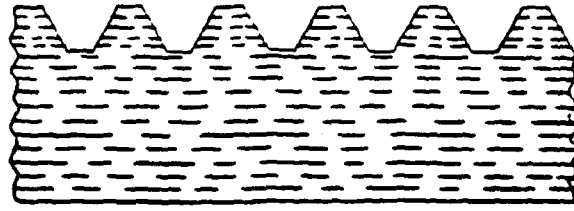
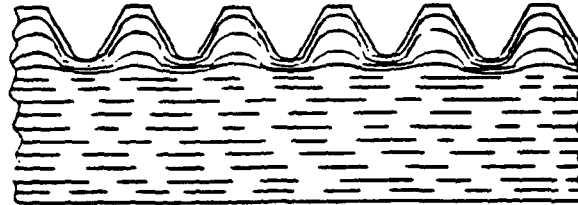
This statement indicates that the threads must not be ground or cut onto the finished blanks. Figure 14 illustrates the different grain flow pattern between a ground or cut thread

Figure 14. Schematic illustrating difference in grain flow pattern between cut versus rolled threads.

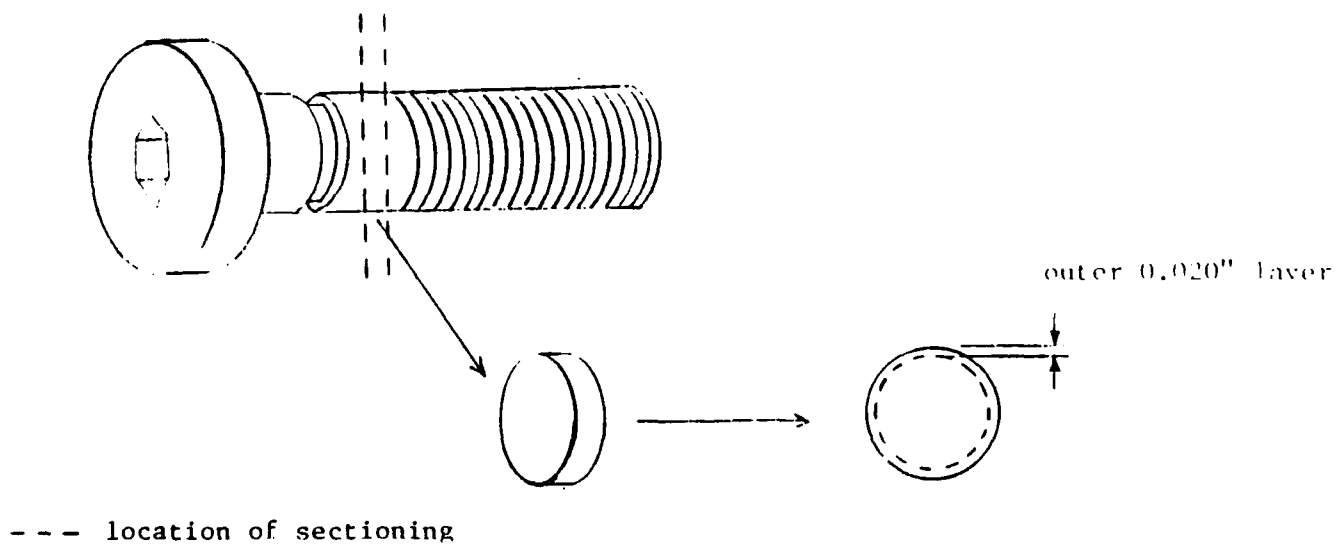
Figure 19. Schematic illustrating sectioning of chemical analysis sample.

Material was sectioned from two different bolts for chemical analysis to establish conformance with drawing requirements and to compare the level of carbon in the surface region. The first bolt chosen for examination was the failed Bolt A and the other was bolt 0437. Pieces of the failed Bolt A (which appeared to have a carburized layer through metallographic and microhardness findings) and Bolt 0437 (which was determined to have little to no carburization) were subjected to chemical analysis. The chemical composition of the bolts was determined by atomic absorption and inductively-coupled argon plasma emission spectrometry. The carbon and sulfur contents were determined by the LECO combustion method. The bolts were sectioned as shown in Figure 19. A disk was sectioned from the shank of each bolt, and the outer 0.020 inches of the disk circumference was removed (see Figure 19) and analyzed separately. The chemical compositional requirements of MIL-S-7108 steel, commercially known as *Hy-Tuf* steel are listed with the chemical composition findings in Table 1.

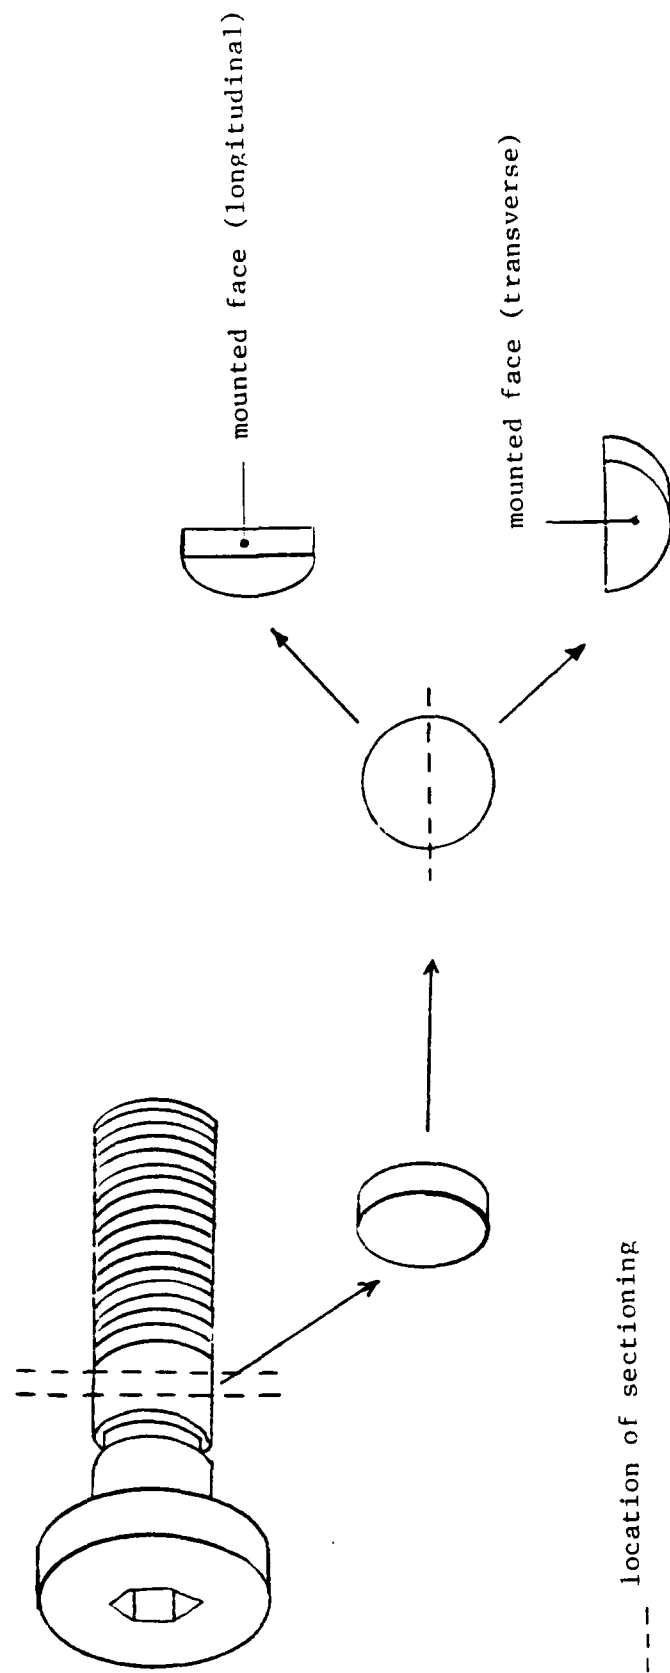
Figure 22. Schematic illustrating method of metallographic sectioning.

Hardness tests were performed on sections of each of the two failed launcher bolts examined at MTL. The bolts were sectioned, as shown in Figure 22, to obtain both transverse and longitudinal cross sections. Both bolts (Bolt A and B) showed signs of decarburization, as noted previously. Knoop microhardness measurements were performed through the carburized layer transversing into the core of the samples in a step-like manner, as illustrated in Figure 23. The diagonal readings were spaced 0.004 inches in the x-direction and 0.002 inches in the y-direction.

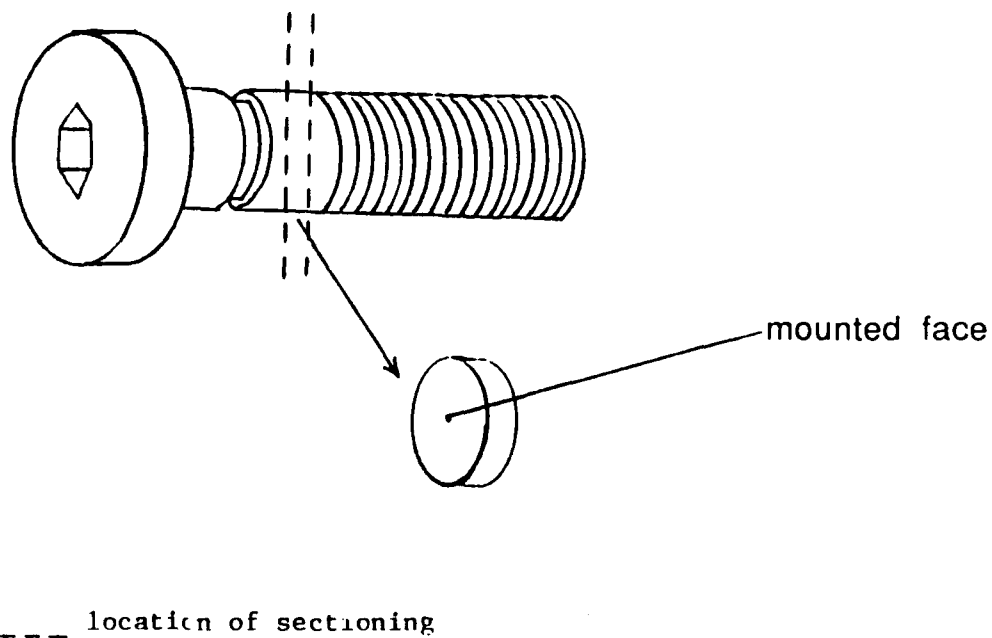
Figure 24. Method of metallographic sample sectioning of sample lot launcher bolts.

The launcher bolts were subsequently sectioned as shown in Figure 24, such that a transverse circular cross section was obtained. These circular sections were mounted and polished before Knoop microhardness measurements were performed in the manner previously described for the failed bolts. The results of this series of microhardness testing are listed in the Appendix. The mounted circular sections were subsequently etched with a 1% Nital solution and examined with the research metallograph to determine the extent of carburization optically. Table 5 is a listing of the bolts examined, the degree of carburization, the range of microhardness and the condition of the bolt (based on microhardness and metallography). A basic rating system was incorporated to classify the extent of carburization on each of the bolts. The intent of this rating system was to determine if the bolts could be placed in service without the risk of premature failure as a result of carburization, only. Representative photomicrographs of three different levels of carburization are shown in Figures 25 through 27.

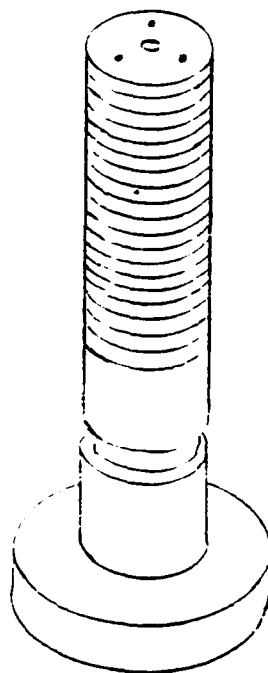
Figure 28. Schematic illustrating location of macrohardness measurements performed on the ends of the launcher bolts.

each of the bolts. The solution was swabbed over the surface for approximately two minutes, and care was taken to prevent base metal attack. Three hardness readings were measured on each bolt in the location shown in Figure 28. The results are listed in Table 6. Care was also taken to avoid the hardness indents which were present on the bolt from the manufacturer.
